Luna G5 1.2 Customer Release Notes

Document #: 007-011301-001 Revision C

Release Notes Issued on: 2010/12/17

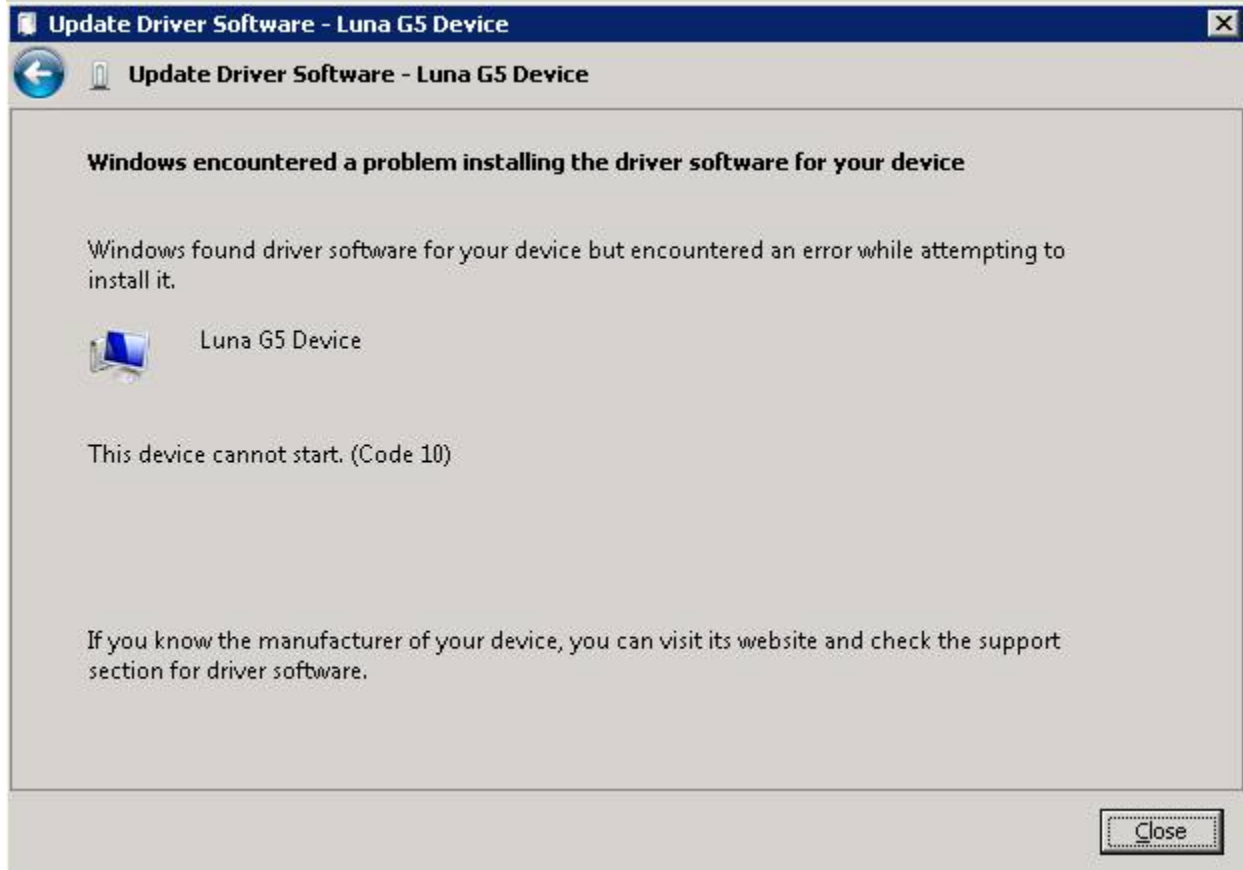
When first installing or updating the Luna G5 driver in Windows Device Manager – a status window reports “Windows found driver software for your device but encountered an error while attempting to install it”. This applies to Windows only. Other operating systems are not affected.

Ignore the error message. After the install/update of the driver, perform a power-cycle of the Luna G5 and it works properly with Windows – the driver is properly installed.

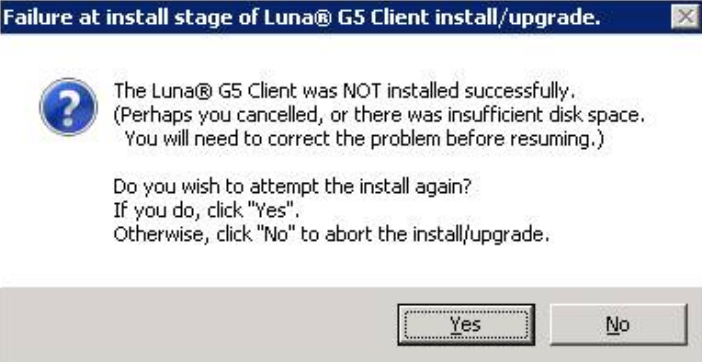
(80788) G5 Windows 64-bit install finishes before it starts	M	<p>Problem: Installing from the CD in a Windows 64-bit computer results in an error message "Failure at install stage of Luna G5 Client install"</p>

<p>The message is misleading.</p>
